# Daily Activity Report

November 18, 2020

738 Upper Mountain Road Site  
738 Upper Mountain Road  
Lewiston, Niagara County, New York

Superfund Technical Assessment & Response Team V  
Weston Solutions, Inc.  
Federal East Division  
Edison, New Jersey 08837

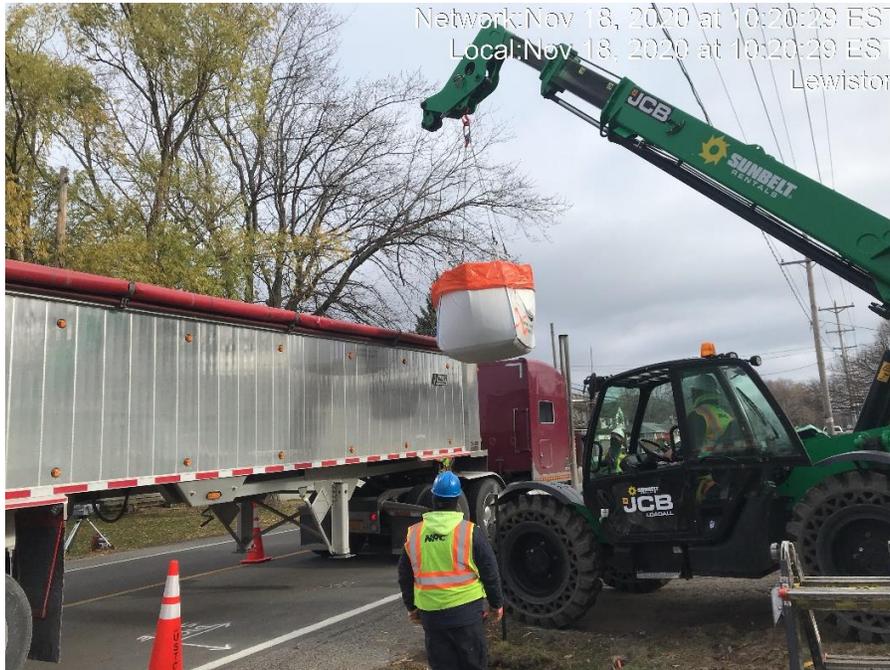
A view of ERRS conducting load out of contaminated soil in supper sacks into a trailer for disposal. Multiple spotters were utilized during this operation, along with traffic control police.

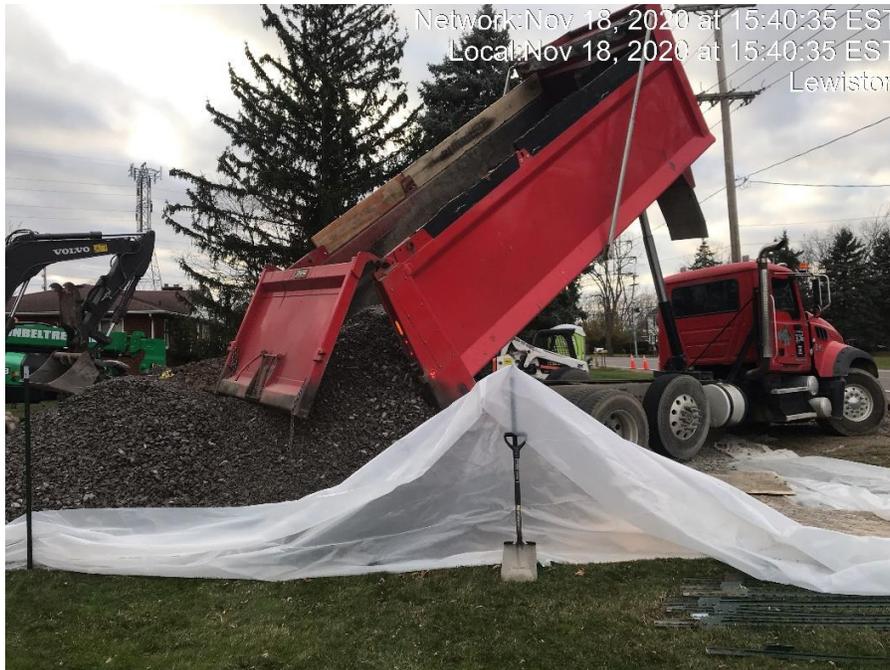
A view of clean fill material being delivered to the staging area on-Site.

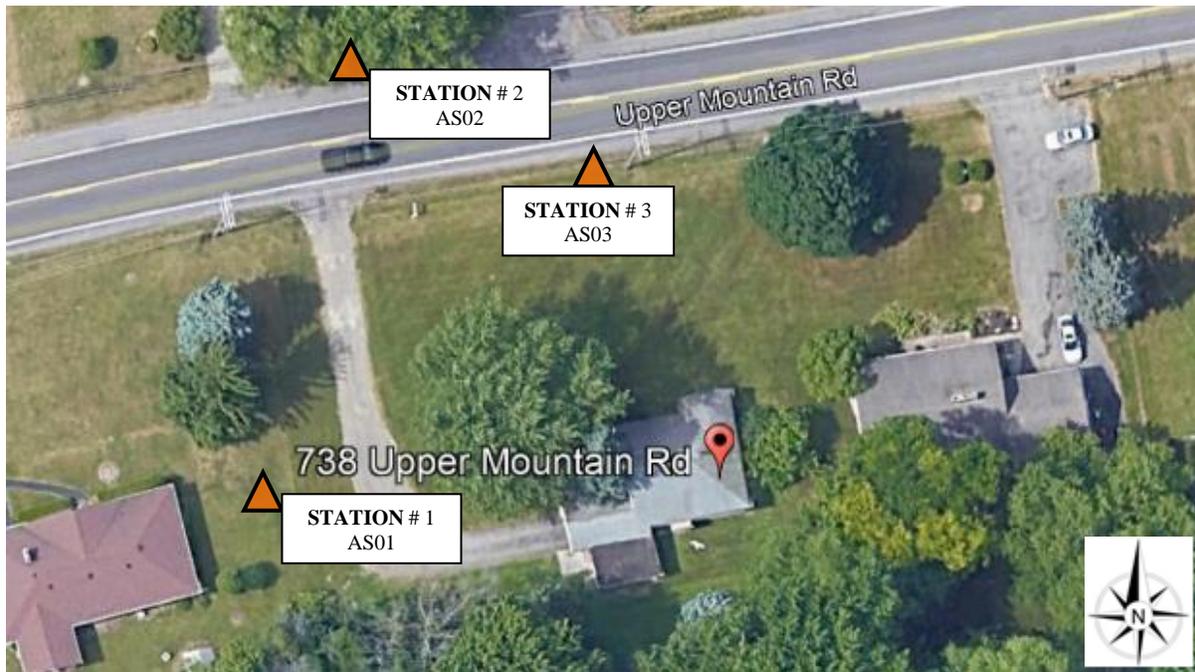
**Air Monitoring Locations:**

The EPA’s START V contractor documented site activities and performed air monitoring on-Site. Using three Dust Track II (model 8533EP) air monitoring devices, three air monitoring stations were set up at the Site. The air monitoring locations were west of the Site facing the property owner’s home (AS01), north of the Site near a telephone poll, facing the immediate excavation area (AS02) and northeast of the Site in a drainage ditch facing the immediate excavation area (AS03). The air monitoring units were calibrated before use and allowed to run for approximately 8-hours. However, due to snow fall throughout the day the three RADēCO units were not deployed. The fugitive dust (total particulate matter) data generated during air monitoring of Site activities was compared to Site-Specific Action Levels (SSALs). Air monitoring data was below the SSAL for this reporting period.
